Confidential Inspection Report

LOCATED AT:
1234 Mayberry St
Tulsa, OK 74114

INSPECTED ON:
Tuesday, January 15, 2019

Inspector, Brad Stringer
About Home Inspection

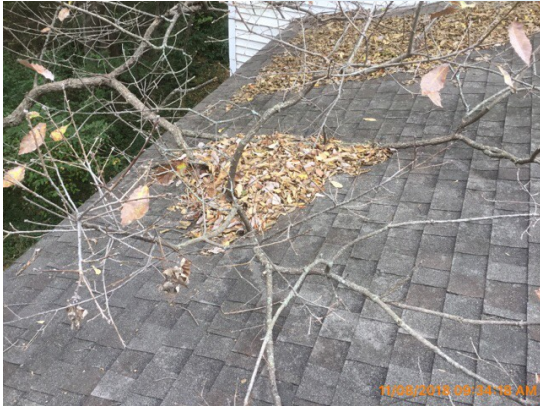
REPR DFCT s-20: - Tree/shrubs contact to roof along portions at the South. Trimming and repair of related damage(s) is required.

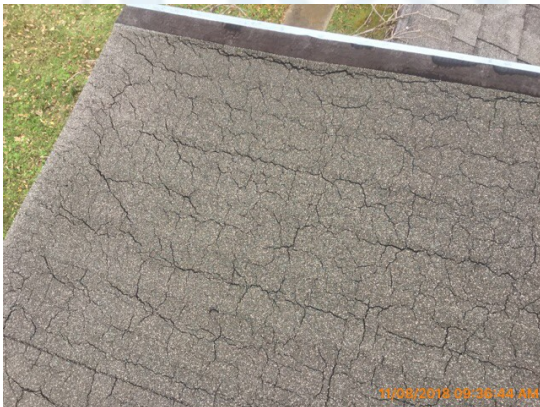
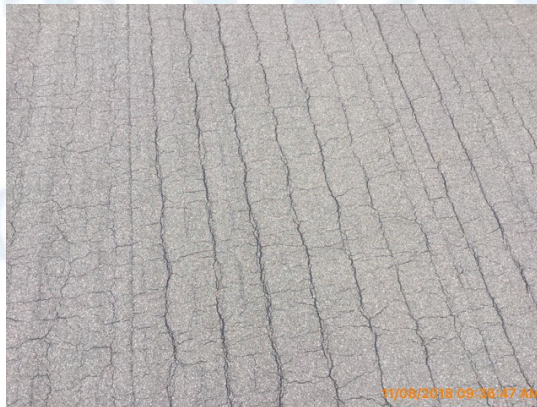
MAJR DFCT s-23: - Heat cracking flat roof was visible, likely due to a lack of proper ventilation of the roof deck. Visible signs of moisture infiltration were noted at the interior indicative of leaks. Evaluation by a roofing contractor for likely need for replacement is advised.

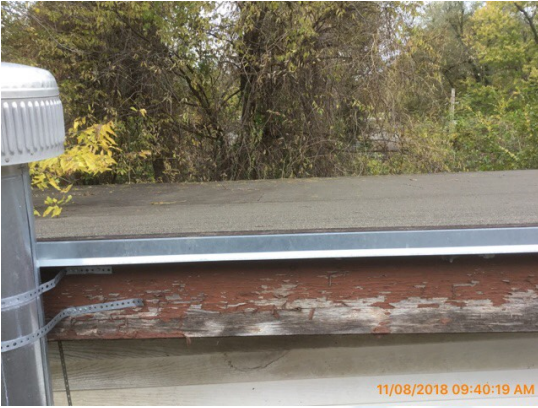
s-24: - Flat roof above the west has a significant "sag" at the center indicative of improper supporting. Evaluation for possible need for corrections/supporting is advised.

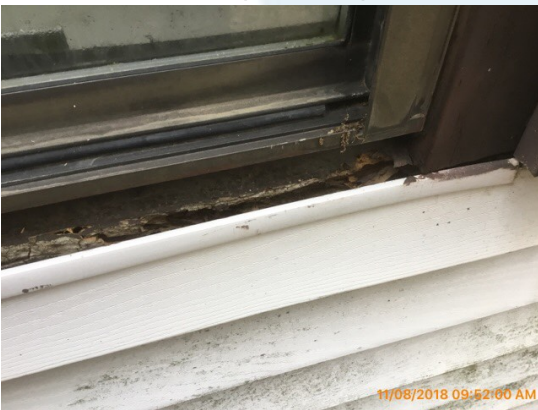
Northeast window

s-34: - Wood rot/delamination noted, but not necessarily limited to the exterior at the following locations:

- northeast window trim (See Photo 1)
 - front entry threshold (See Photo 2)
 - southeast window trim (See Photo 3)
 - rot/pest damages to the east side of the overhead garage door. (See Photo 4)
- We recommend repair or replacement.

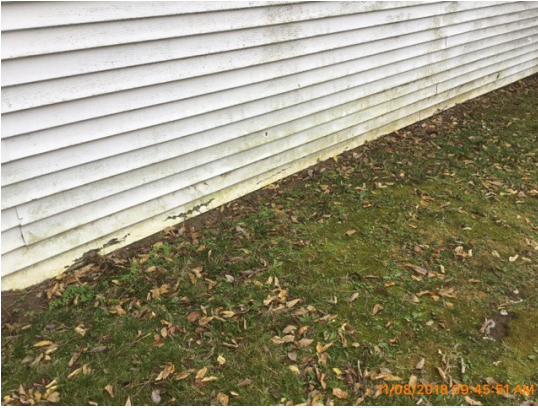
Northeast

s-36: - Vinyl siding is damaged/warping/detaching in various locations significant as to warrant further evaluation for repairs/replacement.

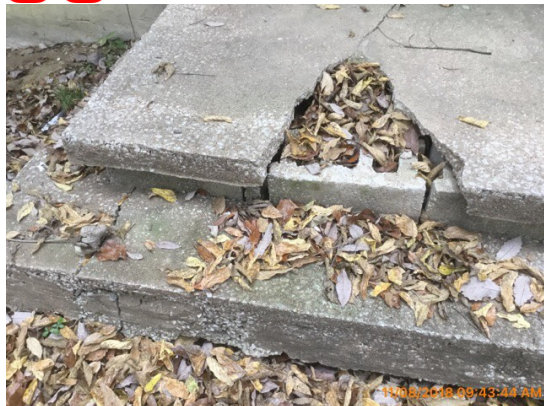
MAJR **DFCT** **s-52:** - Back porch is cracked and damaged and in need of repair.

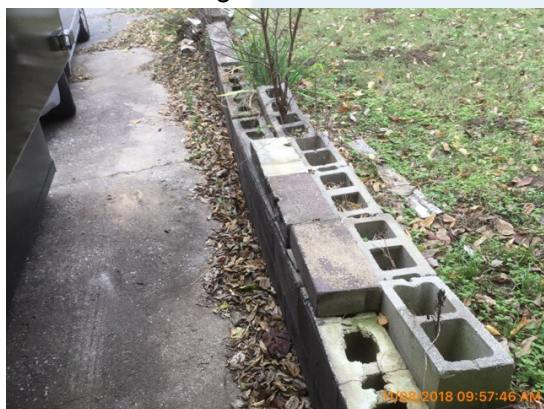
REPR **DFCT** **s-53:** - Low-level retaining wall at the east side of the driveway is in various stages of deferred maintenance/degradation and in need of repair.

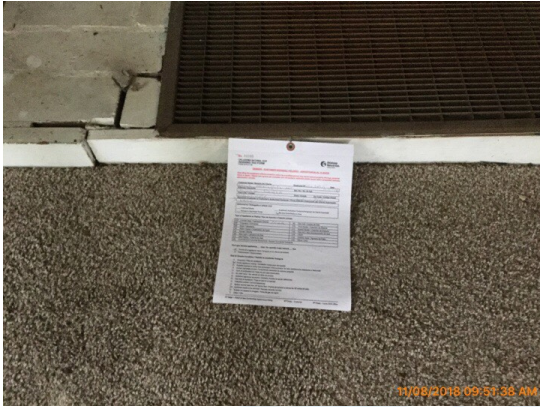
MAJR SFTY DFCT s-54: - Floor furnace at the living room has been red tagged by ONG for safety violations regarding its installation. There are also visible signs of a past fire/charring of wood at the floor joist framing at the crawl space. We recommend removal and replacement with a central HVAC system by a licensed heating and air contractor.

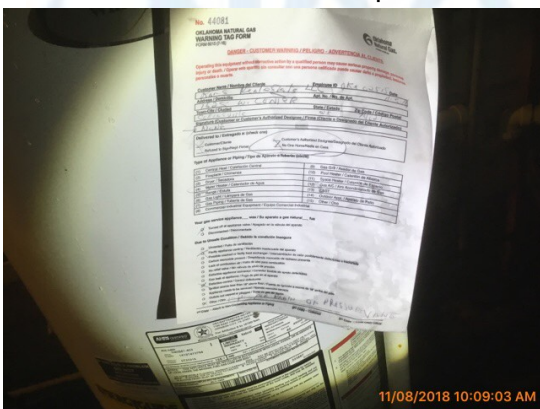
MAJR DFCT s-68: - Water heater is red tagged by ONG as being improperly vented, having a PVC discharge tube on the T&P valve, it is also not secured from vehicle contact, is not in a drywall enclosure, and is not installed in a pan in the event of a leak. Evaluation for correction by qualified plumbing contractor is needed. Not functional at inspection.

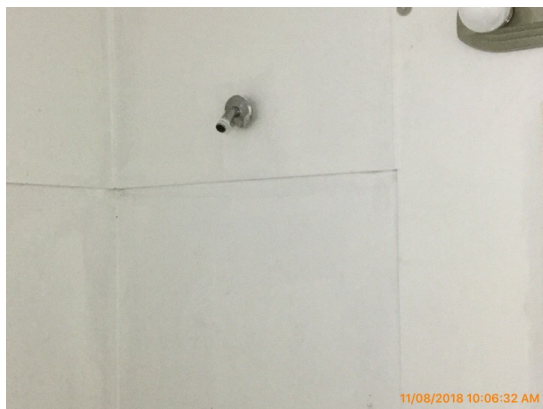
MINR **DFCT** **s-69:** - Shower head(s) is/are missing at the upstairs bathroom(s). Install to insure proper function.

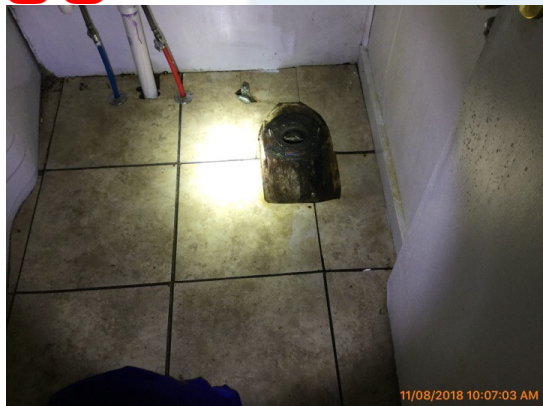
REPR **DFCT** **s-71:** - Toilet is missing at the upstairs bathroom. Replacement required.

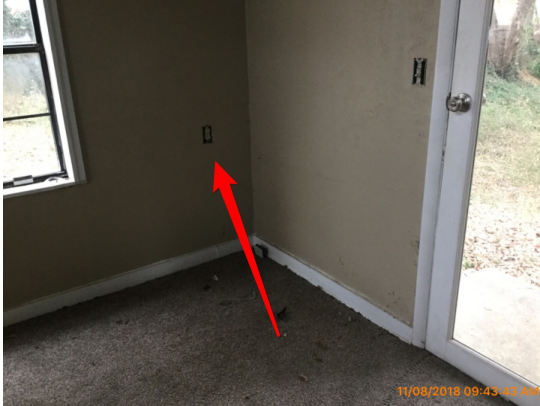
REPR **DFCT** **s-89:** - Receptacle at the Southeast wall of the living room does not show to have power. We recommend repair or replacement.

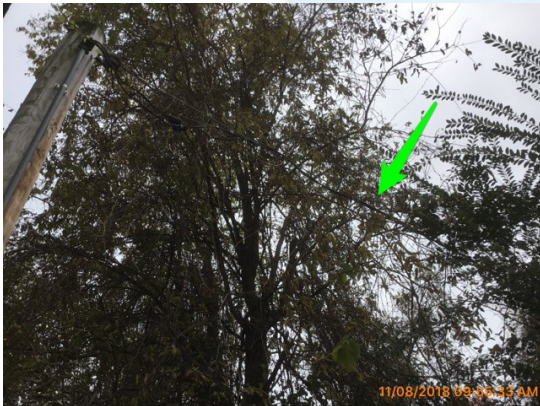
SFTY **DFCT** **s-93:** - Trees contacting the incoming overhead electrical service wire. Potential for mechanical damage/shock/fire. Contacting of service provider for trimming is advised.

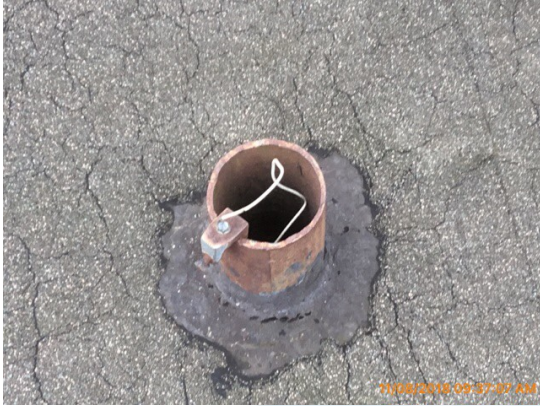
Light at the carport

s-94: - Non professional electrical practices noted at:

Due to the amounts of non professional wiring visible throughout the residence, we recommend full evaluation by a licensed electrician for repair/correction to a professional standard for safety.

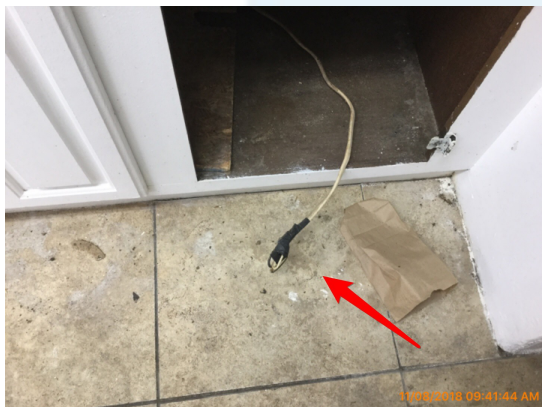
Exposed Romex under kitchen sink.

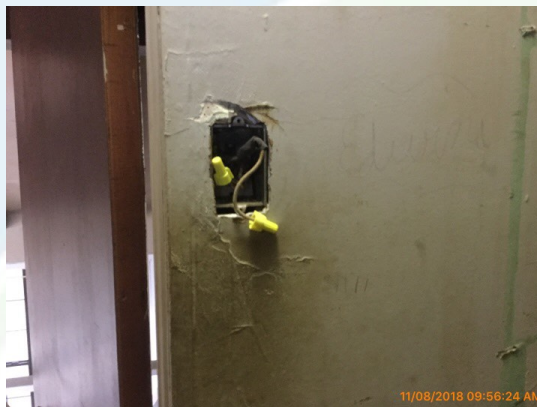
Improperly terminated wire southwest kitchen cabinetry

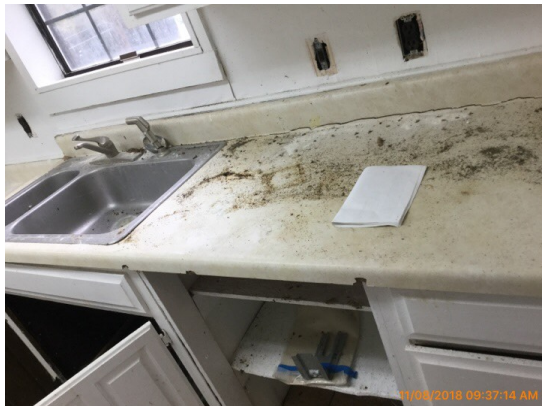
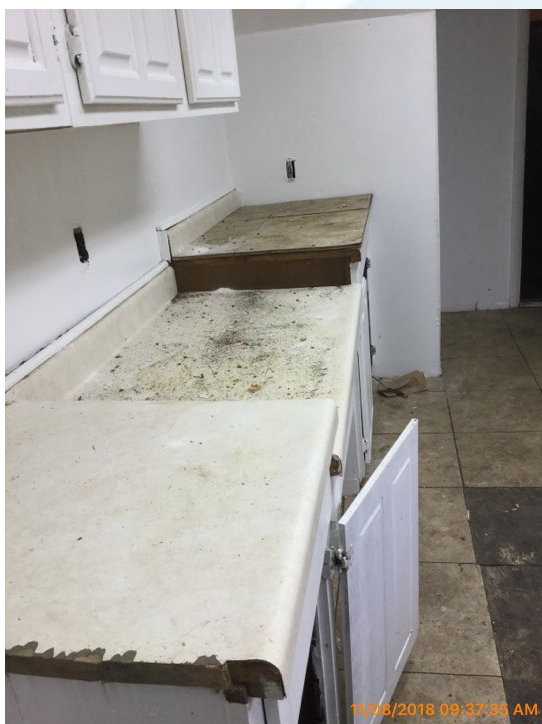
MAJR **DFCT** **s-98:** - Kitchen cabinets have varying amounts of wear and tear/damage to the point that budgeting for repairs/replacement is advised and should be budgeted for.

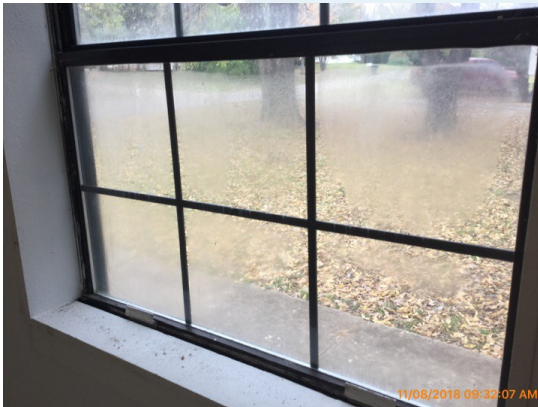
MNTC **DFCT** **s-108:** - Failed thermal seal(s) noted at thermal windows throughout residence. Window(s) has/have condensation/fogging. Although it does not affect function and thermal resistance value, evaluation for cost to replace is advised for improved function and aesthetics.

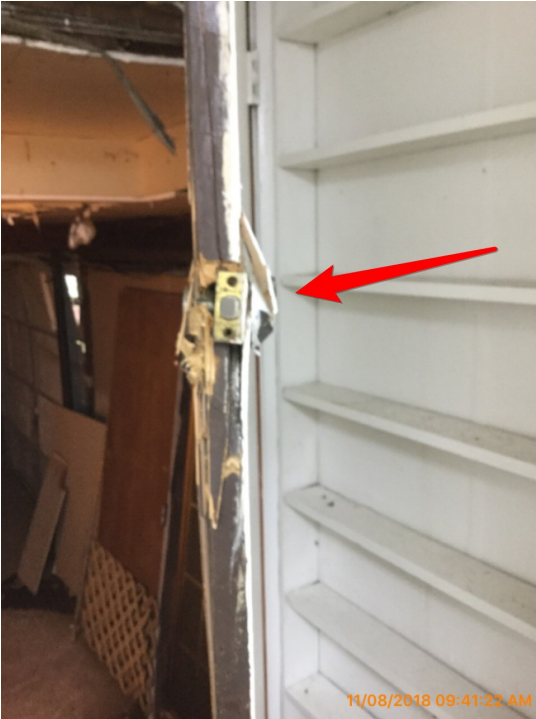
s-112: - Pedestrian door to garage and the front entry door show signs of forced entry. Recommend replacement of door and repair as necessary to ensure safety and security of the residence.

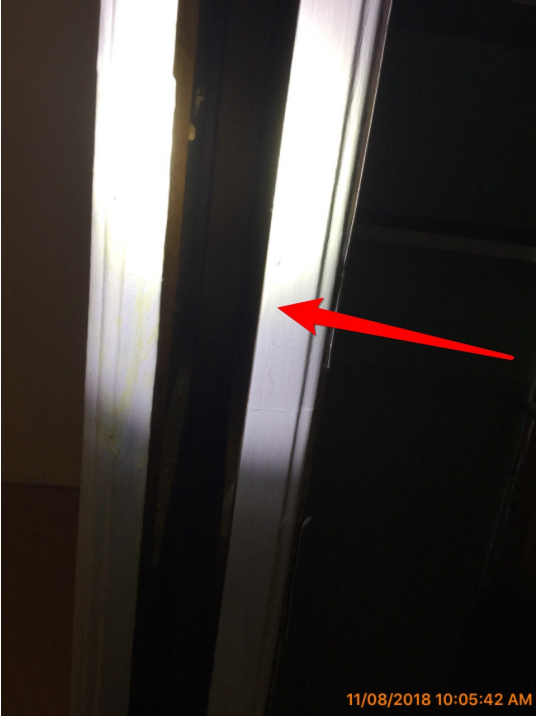
s-113: - Upstairs southeast closet pocket door is missing. We recommend repair or replacement.

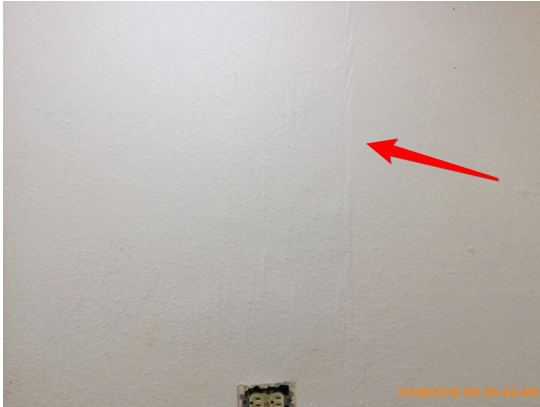
North dining room

EVAL **DFCT** **s-114:** - Moisture damages to interior wall at the following locations including but not limited to:

Evaluation of the roof for likely need for repairs, as well as repair or replacement of all affected interior finish components is needed.

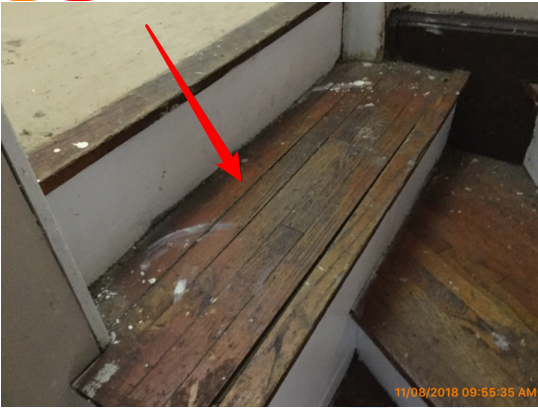
SFTY **DFCT** **s-116:** - Sagging of some interior stair treads. Recommend correction for improved safety.

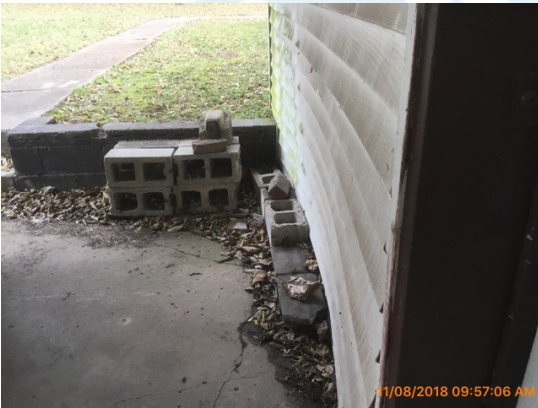
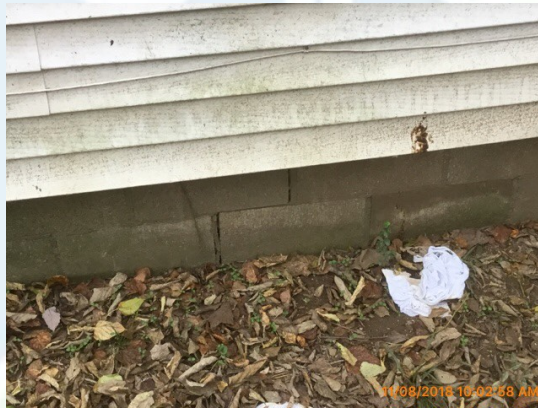
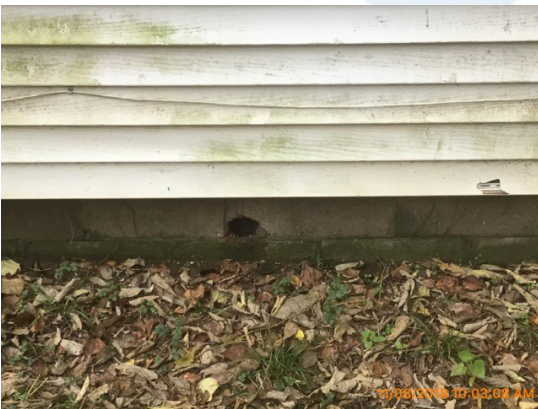
- The north facing wall of the garage just east of the overhead door is bowed inward indicative of likely impact. (See Photo 1)
- mortar step crack at the west facing southwest corner. (See Photo 2)

- hole in the foundation wall at the west/northwest. (See Photo 3)
- floor at the kitchen/living room common wall deflects significantly at the point of the contact of the common wall.

- reinforcement or additional support was likely not installed at the crawl space at the affected area of floor deflection.
- we recommend further evaluation by a qualified professional contractor and/or engineer to determine a course of action for correcting the deflection in the flooring prior to any intended upgrades to the interior.

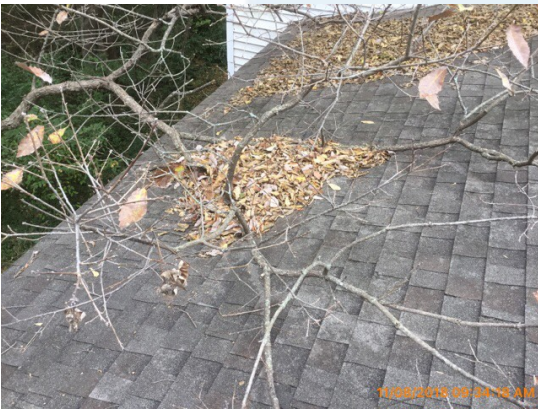
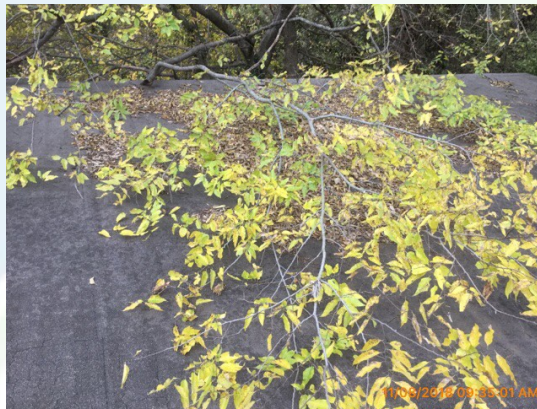
REPR **DFCT** 20: - Tree/shrubs contact to roof along portions at the South. Trimming and repair of related damage(s) is required.

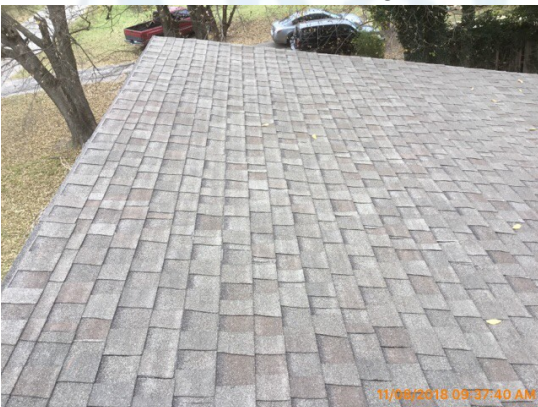
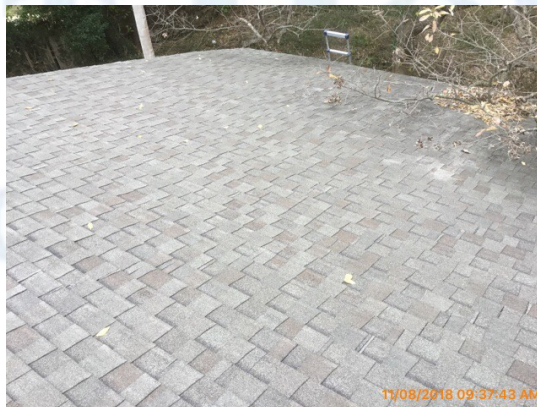
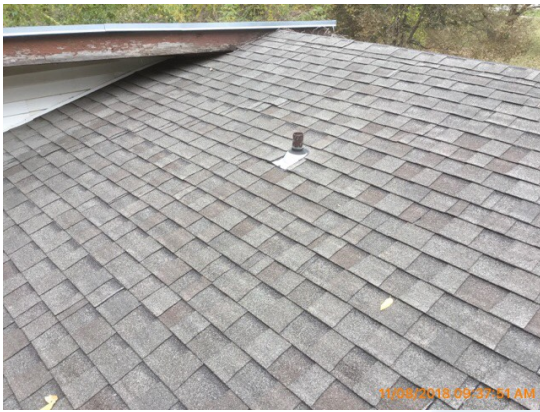
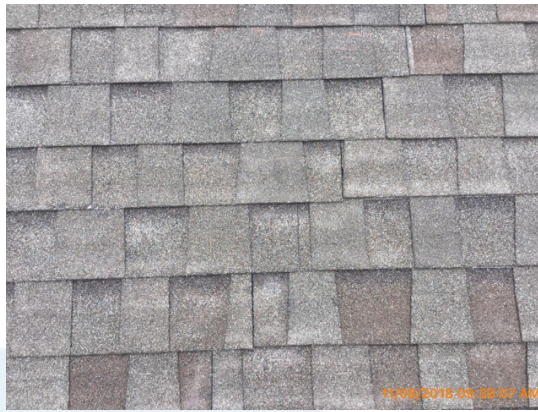
21: - Shingled portions of the roof appear to be in overall serviceable repair with typical amounts of wear and tear associated with its age.

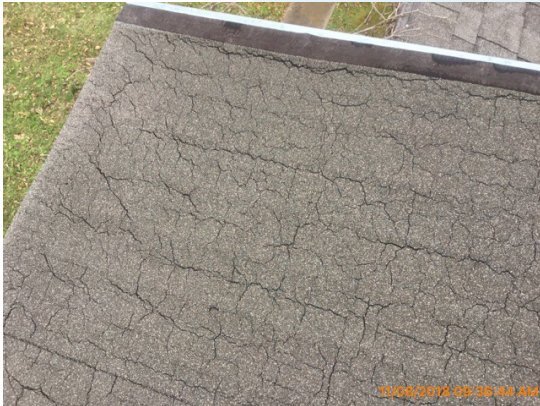
MAJR DFCT 23: - Heat cracking flat roof was visible, likely due to a lack of proper ventilation of the roof deck. Visible signs of moisture infiltration were noted at the interior indicative of leaks. Evaluation by a roofing contractor for likely need for replacement is advised.

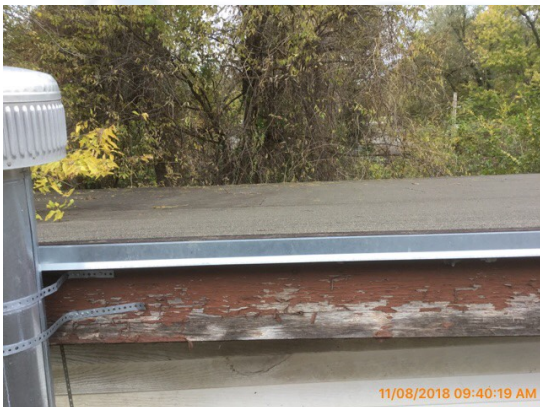
MAJR DFCT 24: - Flat roof above the west has a significant "sag" at the center indicative of improper supporting. Evaluation for possible need for corrections/supporting is advised.

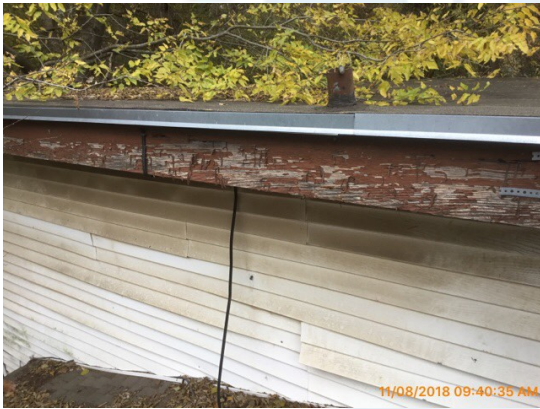
MNTC 32: - Flaking paint/exposed wood and chalking at portions of the exterior at various locations to the point that maintenance scraping/caulking/priming/painting is advised to ensure against rot and moisture related damages.

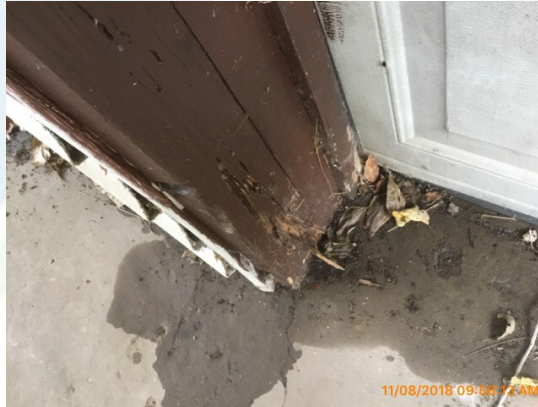
Southeast window

REPR DFCT 34: - Wood rot/delamination noted, but not necessarily limited to the exterior at the following locations:

- northeast window trim (See Photo 1)
 - front entry threshold (See Photo 2)
 - southeast window trim (See Photo 3)
 - rot/pest damages to the east side of the overhead garage door. (See Photo 4)
- We recommend repair or replacement.

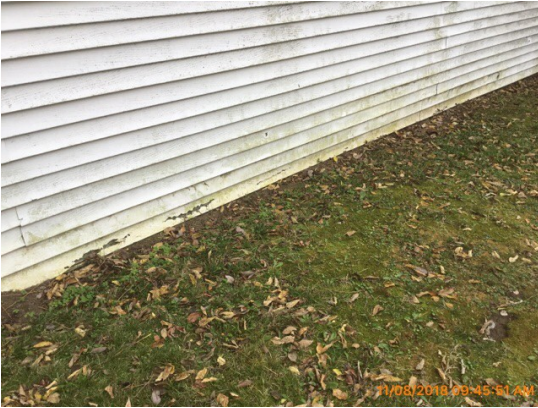
Northeast

REPR DFCT 36: - Vinyl siding is damaged/warping/detaching in various locations significant as to warrant further evaluation for repairs/replacement.

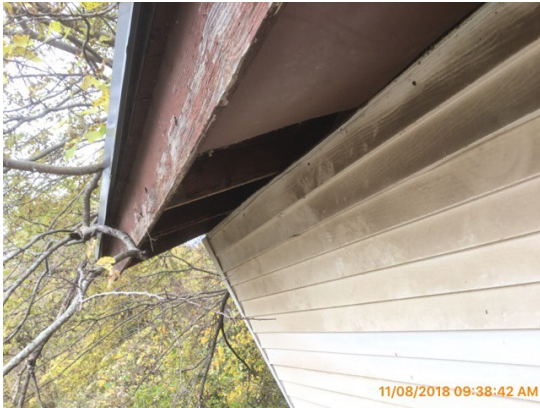
East second story

REPR **DFCT** **39:** - Wood rot at soffit and fascia at various locations. Evaluation for repairs by a qualified contractor is required.

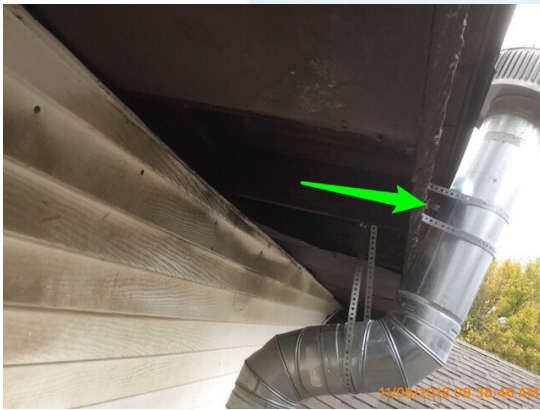
SFTY **DFCT** **40:** - Flue for gas fired appliance is in direct contact with combustible material at the roof penetration. Potential fire hazard. Correction is required.

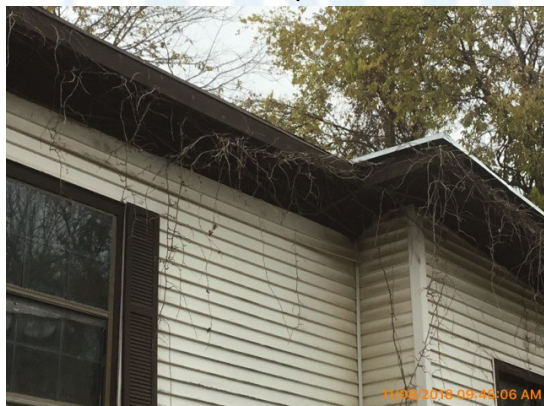
MNTC 50: - Vines growing on the exterior wall can limit drying and lead to damage of exterior siding/veneer. Attractive nuisance to pests. Also restricts direct inspection. Removal is advised.

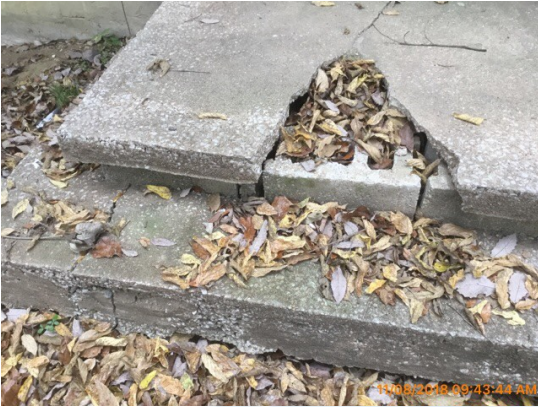
MAJR **DFCT** **52:** - Back porch is cracked and damaged and in need of repair.

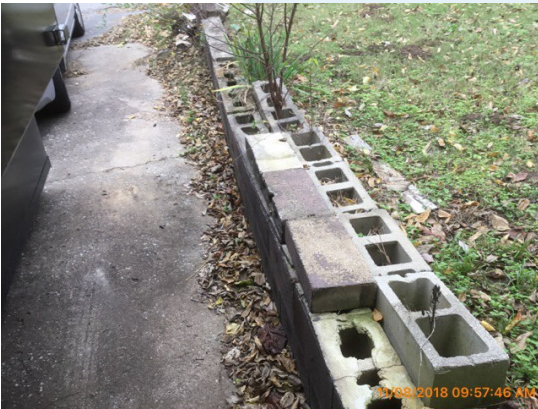
REPR **DFCT** **53:** - Low-level retaining wall at the east side of the driveway is in various stages of deferred maintenance/degradation and in need of repair.

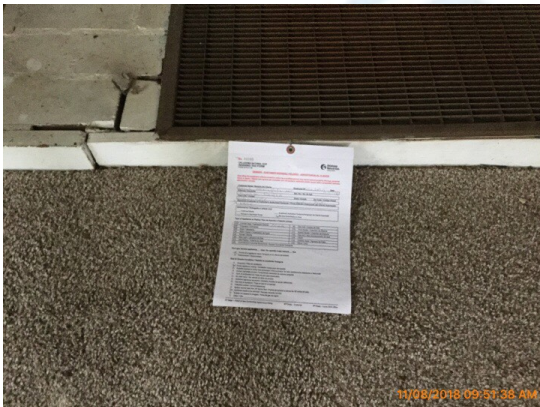
MAJR SFTY DFCT 54: - Floor furnace at the living room has been red tagged by ONG for safety violations regarding its installation. There are also visible signs of a past fire/charring of wood at the floor joist framing at the crawl space. We recommend removal and replacement with a central HVAC system by a licensed heating and air contractor.

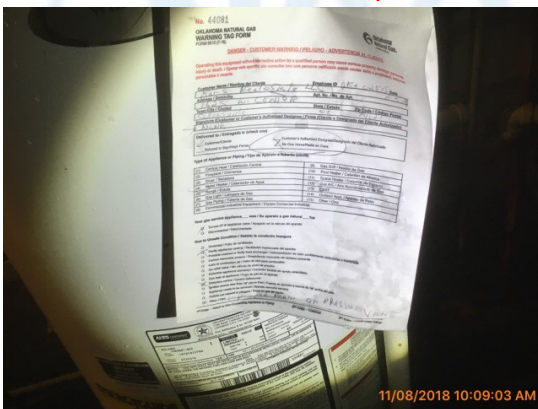
MAJR **DFCT** 68: - Water heater is red tagged by ONG as being improperly vented, having a PVC discharge tube on the T&P valve, it is also not secured from vehicle contact, is not in a drywall enclosure, and is not installed in a pan in the event of a leak. Evaluation for correction by qualified plumbing contractor is needed. Not functional at inspection.

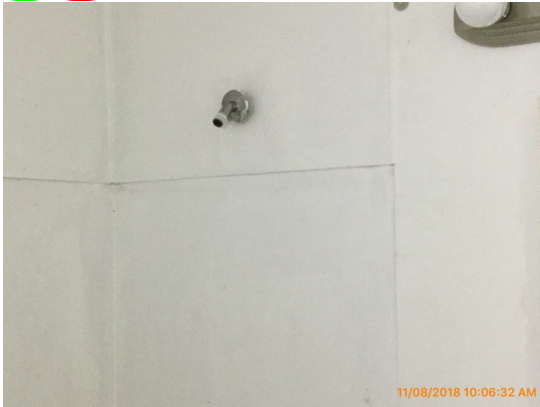
69: - Shower head(s) is/are missing at the upstairs bathroom(s). Install to insure proper function.

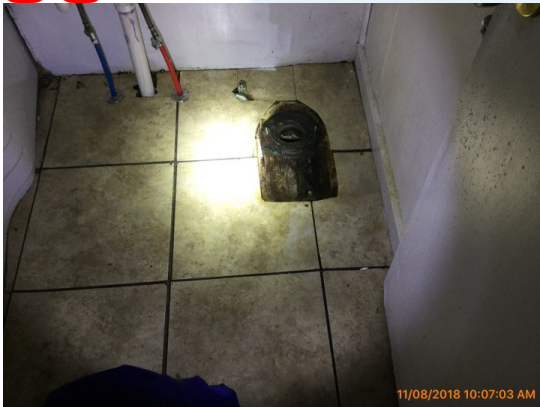
71: - Toilet is missing at the upstairs bathroom. Replacement required.

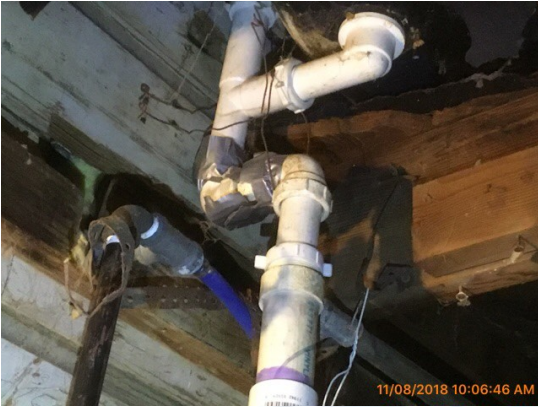
REPR **DFCT** **73:** - Non-professional plumbing noted at the east/north east garage interior near the ceiling, as well as at the east wall near the crawl space entry. Portions of the waistline are secured with vinyl ducting type. Evaluations for professional repair is needed.

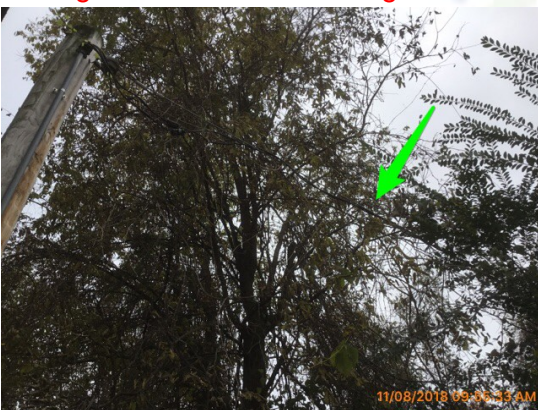
SFTY DFCT 93: - Trees contacting the incoming overhead electrical service wire. Potential for mechanical damage/shock/fire. Contacting of service provider for trimming is advised.

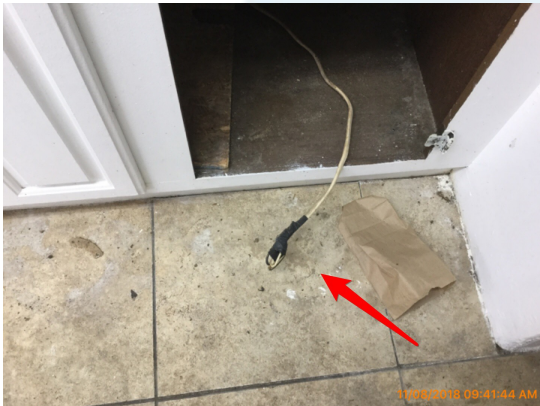
Exposed Romex under kitchen sink.

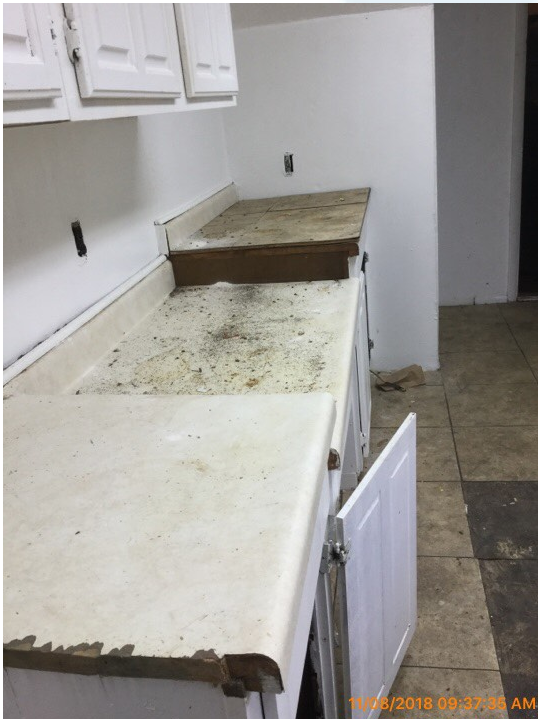
MAJR DFCT 98: - Kitchen cabinets have varying amounts of wear and tear/damage to the point that budgeting for repairs/replacment is advised and should be budgeted for.

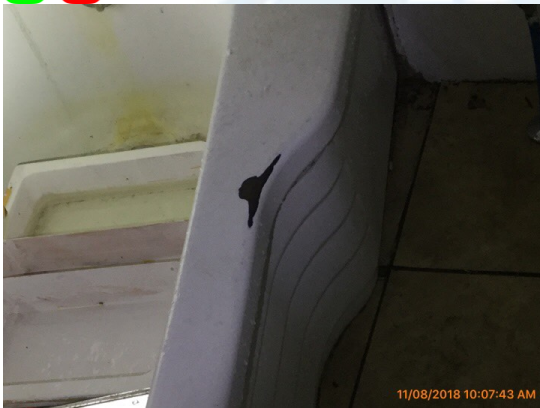
MINR DFCT 103: - Tub at the upstairs bath has chips in the coating. Repairs advised for improved aesthetics.

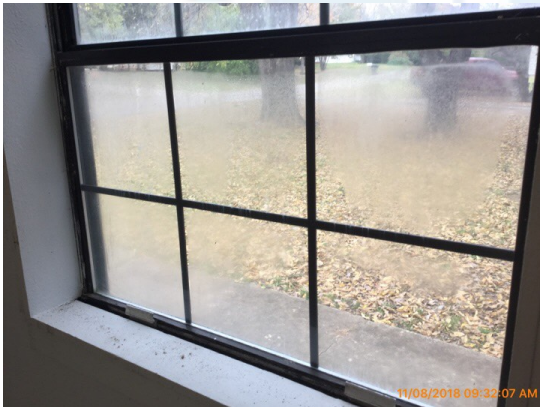
MNTC **DFCT** **108:** - Failed thermal seal(s) noted at thermal windows throughout residence. Window(s) has/have condensation/fogging. Although it does not affect function and thermal resistance value, evaluation for cost to replace is advised for improved function and aesthetics.

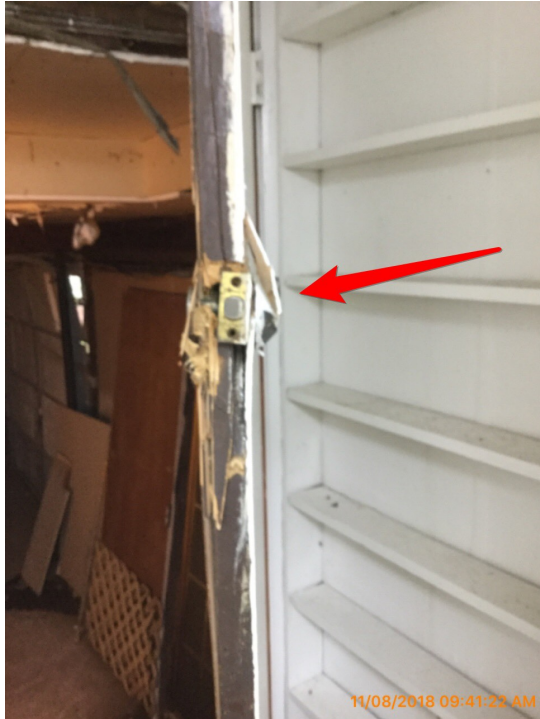
SFTY **DFCT** **112:** - Pedestrian door to garage and the front entry door show signs of forced entry. Recommend replacement of door and repair as necessary to ensure safety and security of the residence.

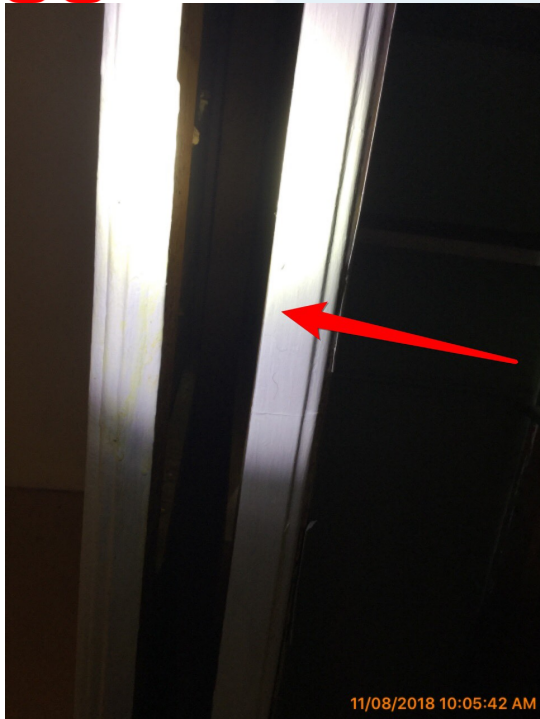
REPR **DFCT** **113:** - Upstairs southeast closet pocket door is missing. We recommend repair or replacement.

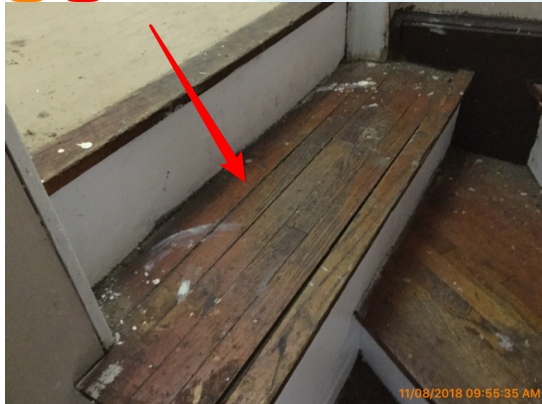
116: - Sagging of some interior stair treads. Recommend correction for improved safety.

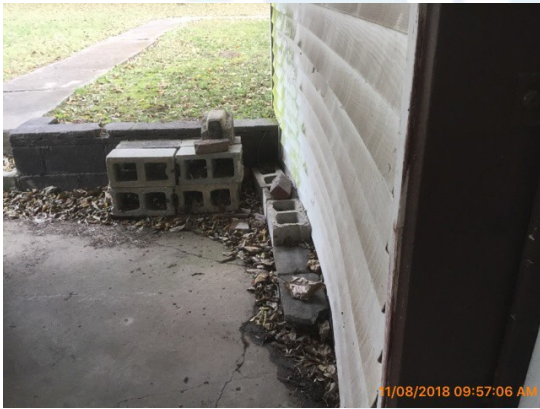
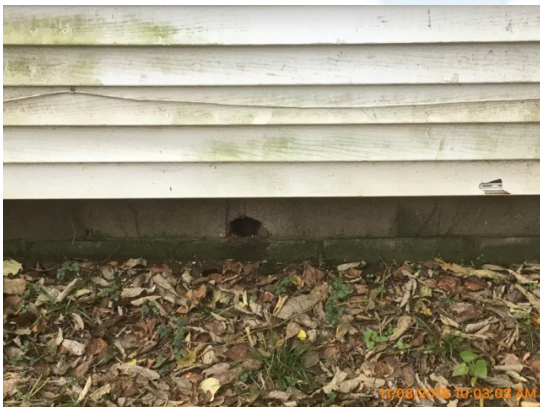
- reinforcement or additional support was likely not installed at the crawl space at the affected area of floor deflection.
- we recommend further evaluation by a qualified professional contractor and/or engineer to determine a course of action for correcting the deflection in the flooring prior to any intended upgrades to the interior.
