Confidential Inspection Report

LOCATED AT:
1234 Mayberry St
Tulsa, OK 74114

INSPECTED ON:
Tuesday, January 15, 2019

Inspector, Brad Stringer
About Home Inspection

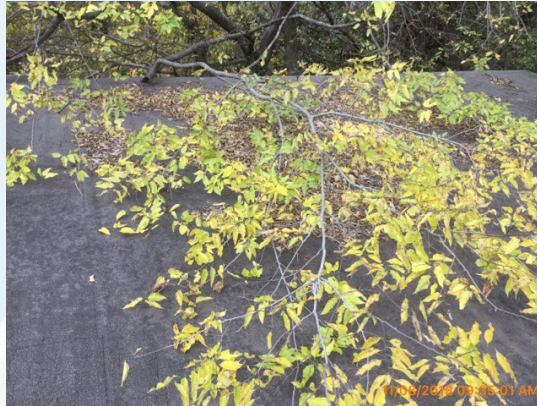
MAJR DFCT s-23: - Heat cracking flat roof was visible, likely due to a lack of proper ventilation of the roof deck. Visible signs of moisture infiltration were noted at the interior indicative of leaks. Evaluation by a roofing contractor for likely need for replacement is advised.

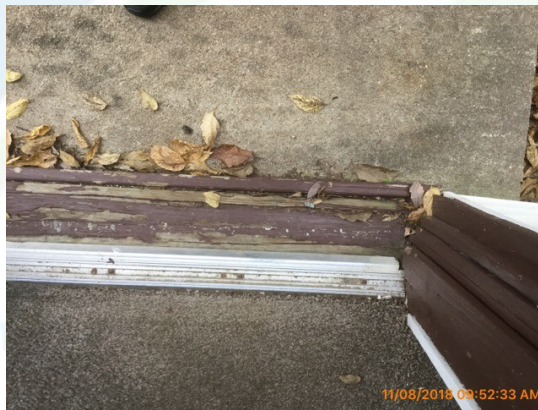
Entry threshold

s-34: - Wood rot/delamination noted, but not necessarily limited to the exterior at the following locations:

- northeast window trim (See Photo 1)
 - front entry threshold (See Photo 2)
 - southeast window trim (See Photo 3)
 - rot/pest damages to the east side of the overhead garage door. (See Photo 4)
- We recommend repair or replacement.

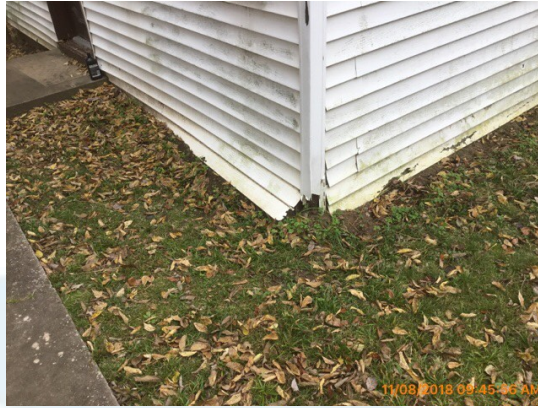
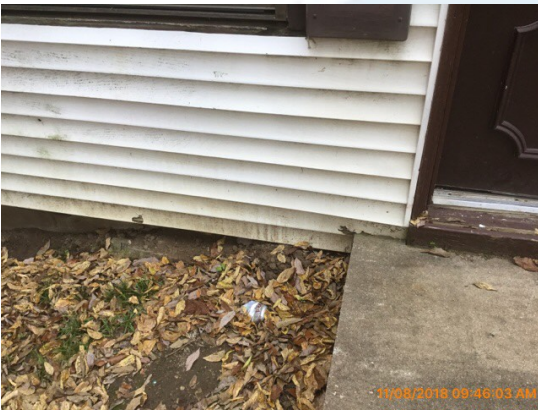
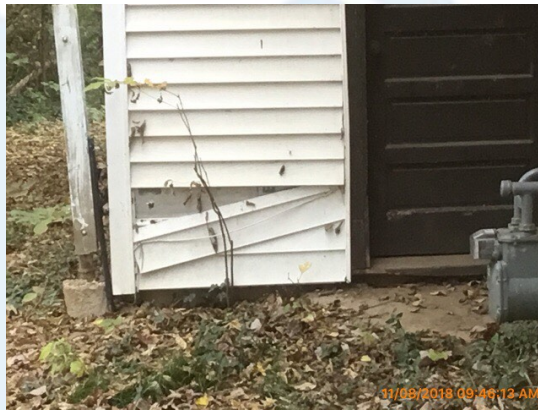
s-36: - Vinyl siding is damaged/warping/detaching in various locations significant as to warrant further evaluation for repairs/replacement.

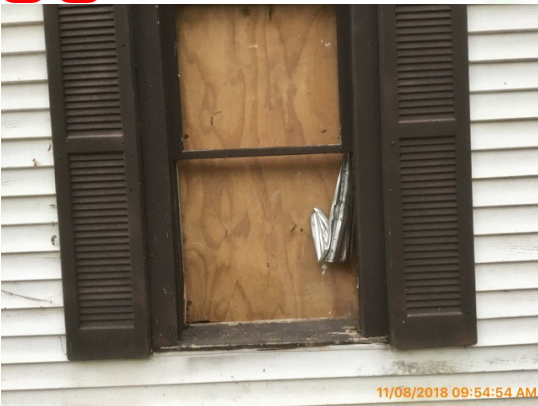
s-38: - Window at the West/South west has been broken out and requires replacement.

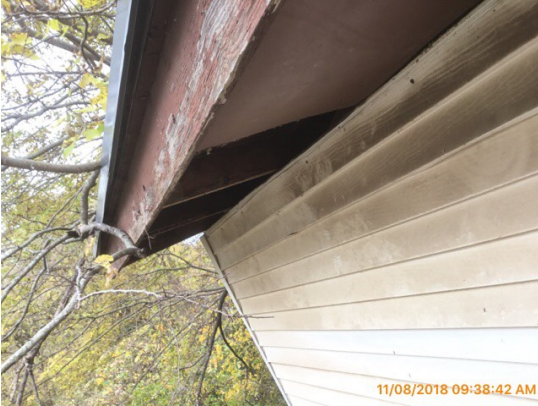
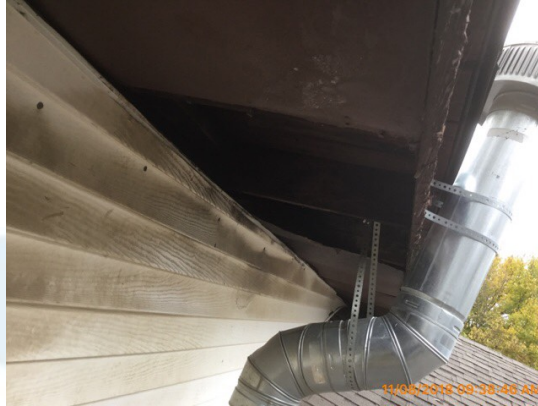
East second story

REPR **DFCT** **s-39:** - Wood rot at soffit and fascia at various locations. Evaluation for repairs by a qualified contractor is required.

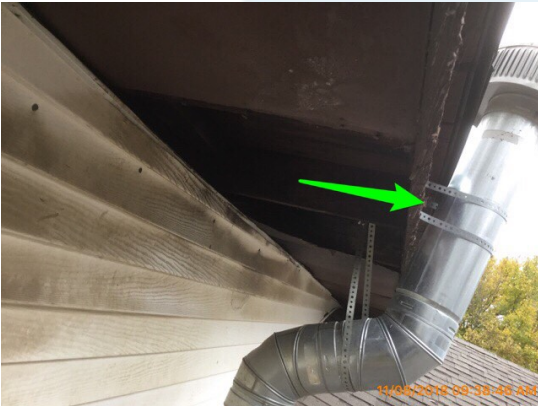
SFTY **DFCT** **s-40:** - Flue for gas fired appliance is in direct contact with combustible material at the roof penetration. Potential fire hazard. Correction is required.

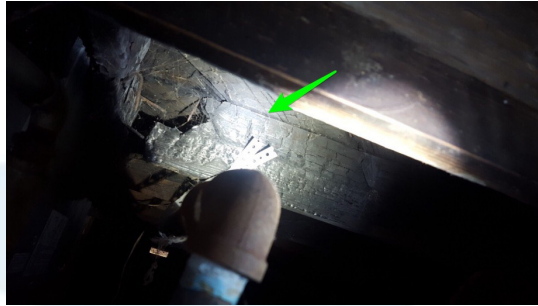
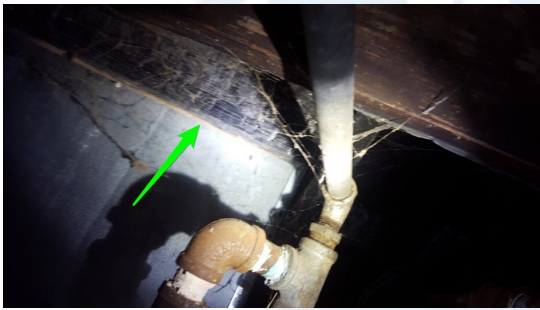
MAJR SFTY DFCT s-54: - Floor furnace at the living room has been red tagged by ONG for safety violations regarding its installation. There are also visible signs of a past fire/charring of wood at the floor joist framing at the crawl space. We recommend removal and replacement with a central HVAC system by a licensed heating and air contractor.

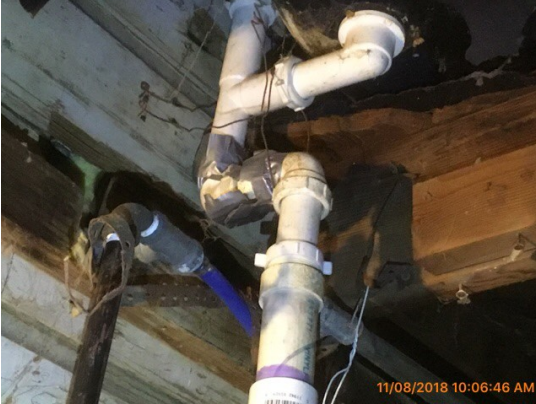
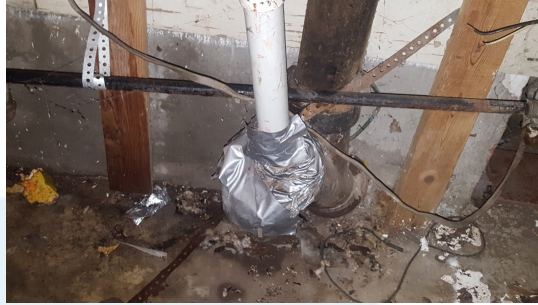
REPR **DFCT** **s-73:** - Non-professional plumbing noted at the east/north east garage interior near the ceiling, as well as at the east wall near the crawl space entry. Portions of the waistline are secured with vinyl ducting type. Evaluations for professional repair is needed.

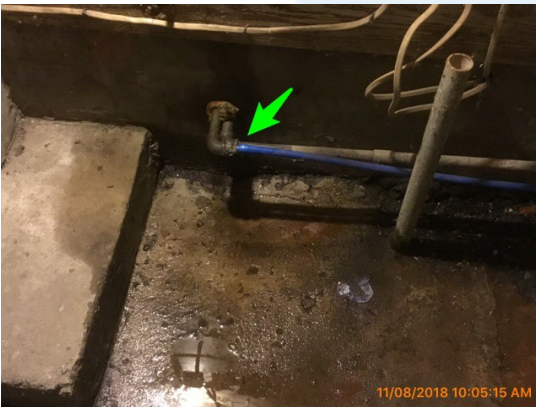
REPR **DFCT** **s-75:** - What appears to be visible leak out of cross-linked polyethylene connection at the north east garage interior. Evaluation for repair required.

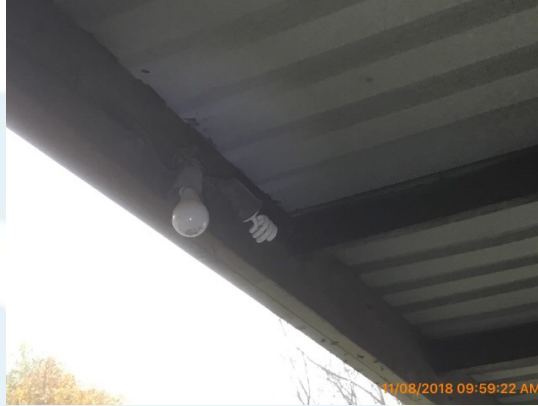
Light at the carport

s-94: - Non professional electrical practices noted at:

- grounding wire routed through the main plumbing stack to the roof (See Photo 1)
- wiring to the light at the front carport (See Photo 2 & 3)
- various locations throughout the garage interior (See Photo 4-10)
- kitchen range receptacle (See Photo 11)

Due to the amounts of non professional wiring visible throughout the residence, we recommend full evaluation by a licensed electrician for repair/correction to a professional standard for safety.

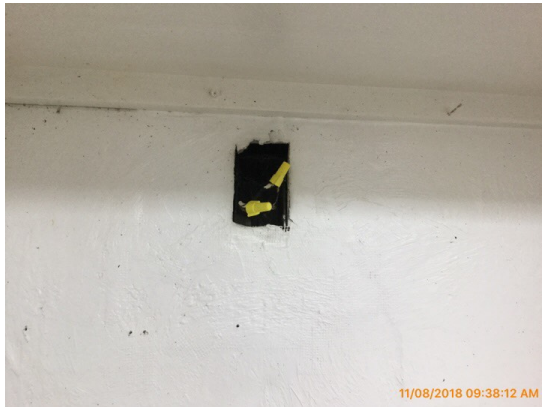
South wall kitchen at refrigerator cavity.

s-95: - Non professional electrical practices noted at:

- south wall of the kitchen at the cavity for the refrigerator (See Photo 1)
- under the kitchen sink (See Photo 2)
- southwest kitchen cabinet (See Photo 3)
- upstairs north closet (See Photo 4)
- west upstairs landing (See Photo 5)

Correction to a professional standard is required for safety.

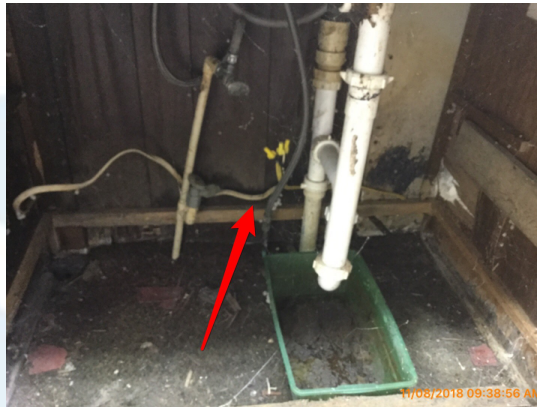
Exposed Romex under kitchen sink.

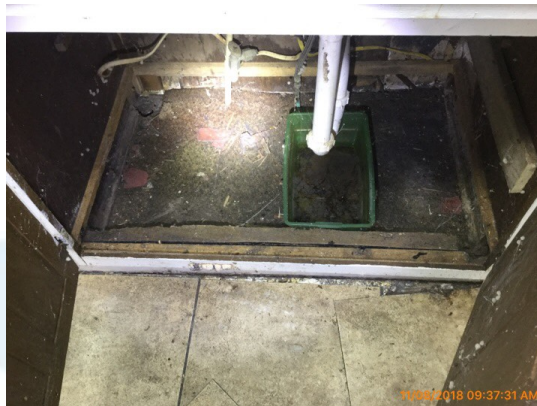
MAJR **DFCT** **s-98:** - Kitchen cabinets have varying amounts of wear and tear/damage to the point that budgeting for repairs/replacement is advised and should be budgeted for.

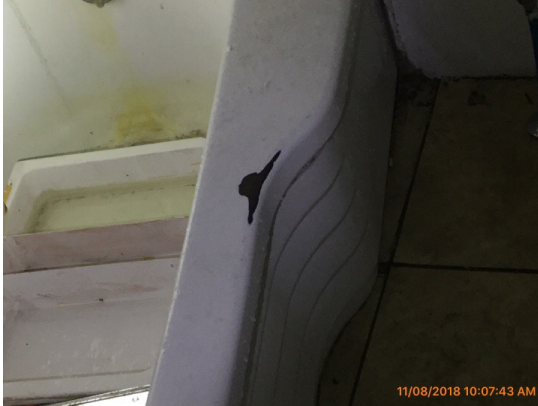
MINR **DFCT** **s-103:** - Tub at the upstairs bath has chips in the coating. Repairs advised for improved aesthetics.

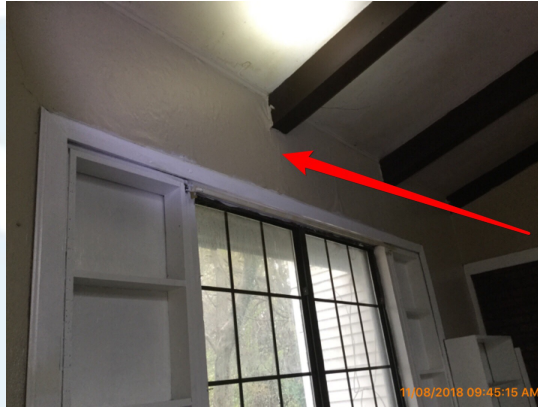
South living room above windows

EVAL **DFCT** **s-114:** - Moisture damages to interior wall at the following locations including but not limited to:

- north dining room. (See Photo 1)
- south wall of living room above windows (See Photo 2)
- upstairs ceiling (See Photo 3)
- north upstairs balcony (See Photo 4)
- upstairs southwest bedroom (See Photo 5)

Evaluation of the roof for likely need for repairs, as well as repair or replacement of all affected interior finish components is needed.

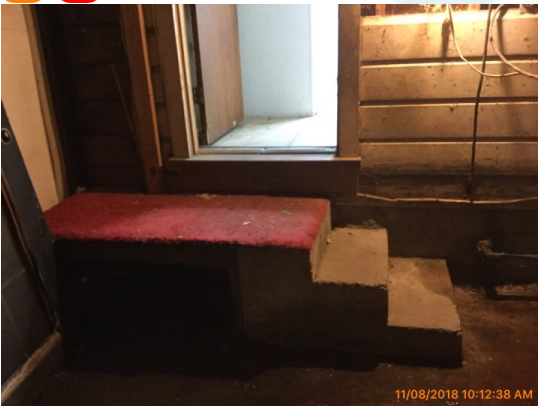
SFTY **DFCT** **s-122:** - Installation of a handrail at the garage steps is advised for improved safety.

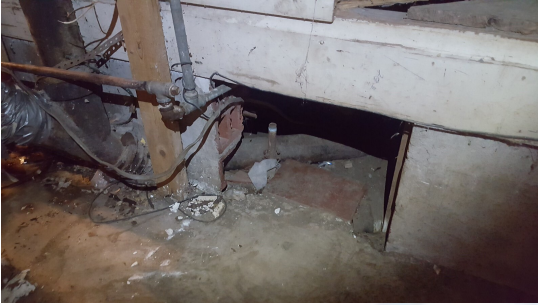
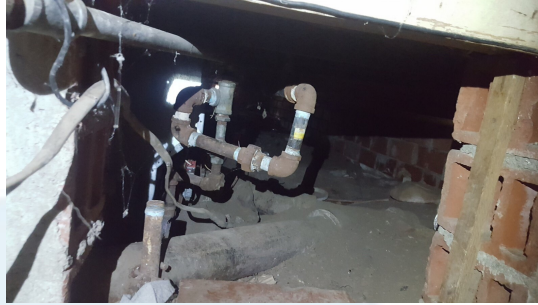
EVAL **DFCT** **s-127:** - Crawl space is inaccessible due to installation of a gas line at the entry blocking access. Opening is also not a minimum of 18x22. Inspection is limited to a "look-in" only from the access scuttle. Improvement of access for inspection is needed in order to complete this General Home Inspection.

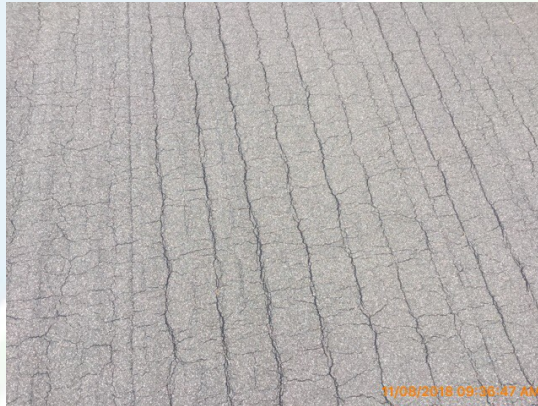
MAJR DFCT 23: - Heat cracking flat roof was visible, likely due to a lack of proper ventilation of the roof deck. Visible signs of moisture infiltration were noted at the interior indicative of leaks. Evaluation by a roofing contractor for likely need for replacement is advised.

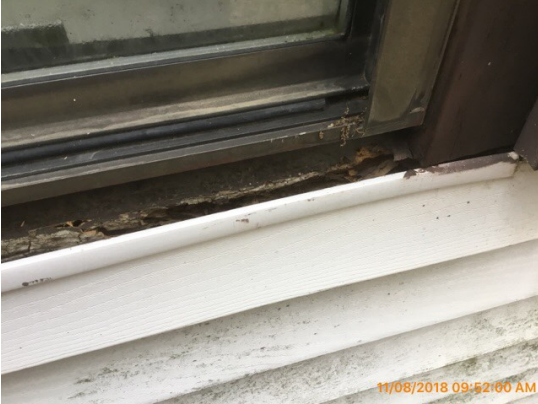
Northeast window

REPR DFCT 34: - Wood rot/delamination noted, but not necessarily limited to the exterior at the following locations:

- northeast window trim (See Photo 1)
 - front entry threshold (See Photo 2)
 - southeast window trim (See Photo 3)
 - rot/pest damages to the east side of the overhead garage door. (See Photo 4)
- We recommend repair or replacement.

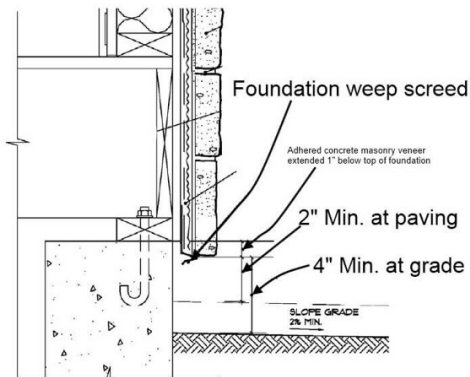
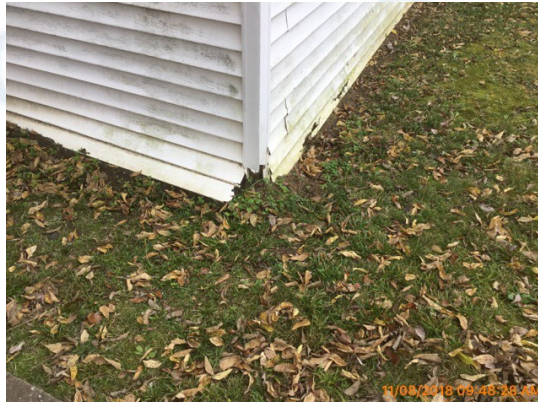
REPR DFCT 35: - Siding is in close proximity or contact with grade. Potential for moisture damages as well as concealment of any pest activity. 4-6" ground clearance is advised. Monitor seasonally for maintenance or correct.

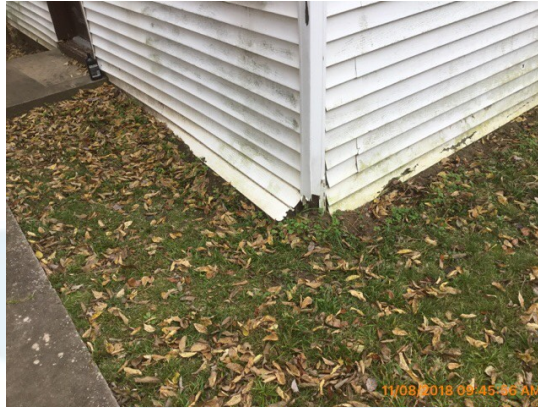
Northeast

REPR DFCT 36: - Vinyl siding is damaged/warping/detaching in various locations significant as to warrant further evaluation for repairs/replacement.

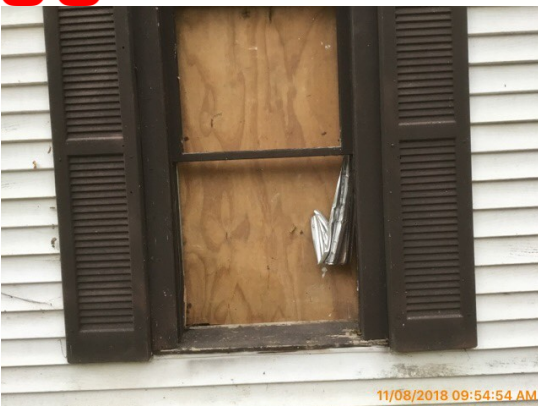
REPR DFCT 38: - Window at the West/South west has been broken out and requires replacement.

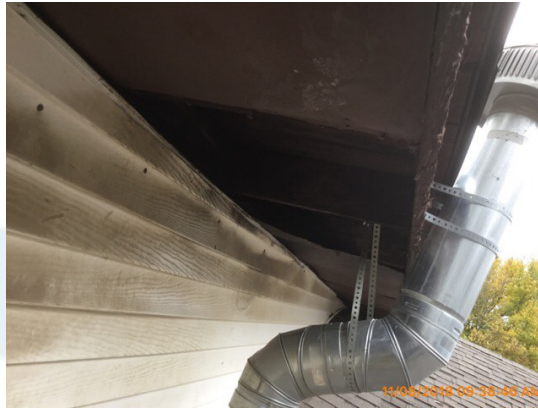
East second story

REPR **DFCT** **39:** - Wood rot at soffit and fascia at various locations. Evaluation for repairs by a qualified contractor is required.

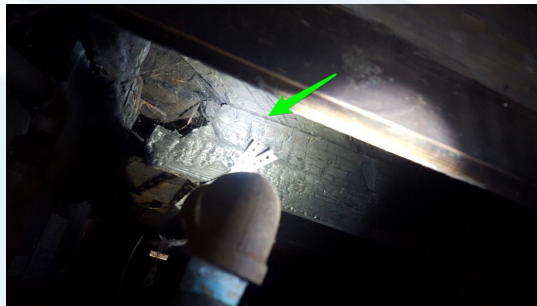
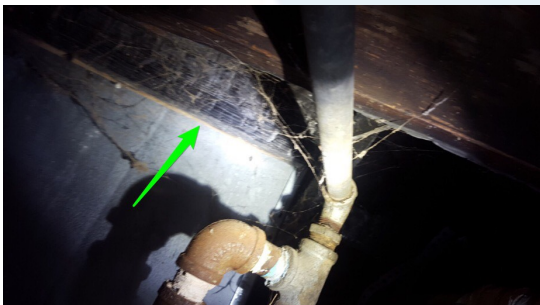
MAJR SFTY DFCT 54: - Floor furnace at the living room has been red tagged by ONG for safety violations regarding its installation. There are also visible signs of a past fire/charring of wood at the floor joist framing at the crawl space. We recommend removal and replacement with a central HVAC system by a licensed heating and air contractor.

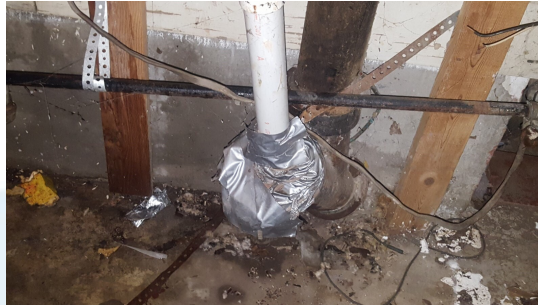
REPR **DFCT** **73:** - Non-professional plumbing noted at the east/north east garage interior near the ceiling, as well as at the east wall near the crawl space entry. Portions of the waistline are secured with vinyl ducting type. Evaluations for professional repair is needed.

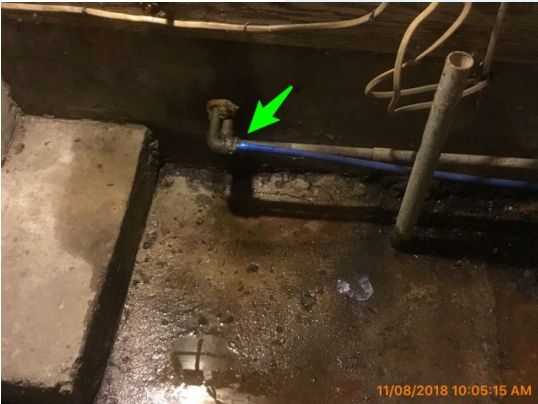
REPR **DFCT** **75:** - What appears to be visible leak out of cross-linked polyethylene connection at the north east garage interior. Evaluation for repair required.

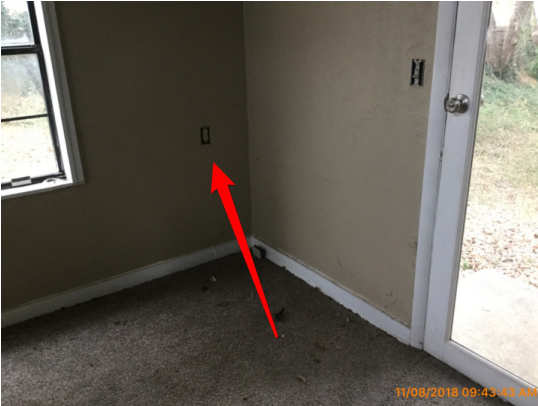
REPR DFCT 89: - Receptacle at the Southeast wall of the living room does not show to have power. We recommend repair or replacement.

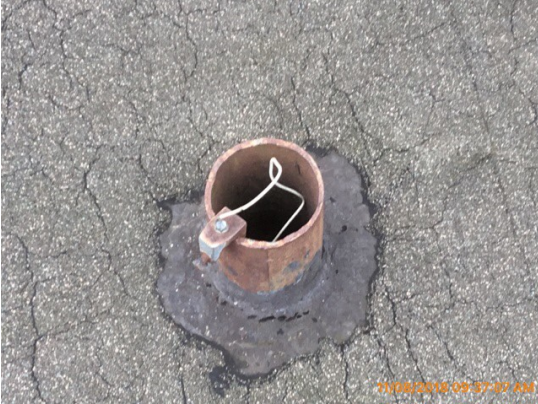
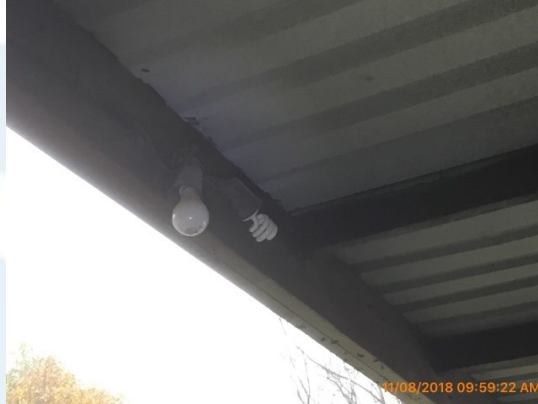
Light at the carport

- grounding wire routed through the main plumbing stack to the roof (See Photo 1)
- wiring to the light at the front carport (See Photo 2 & 3)
- various locations throughout the garage interior (See Photo 4-10)
- kitchen range receptacle (See Photo 11)

Due to the amounts of non professional wiring visible throughout the residence, we recommend full evaluation by a licensed electrician for repair/correction to a professional standard for safety.

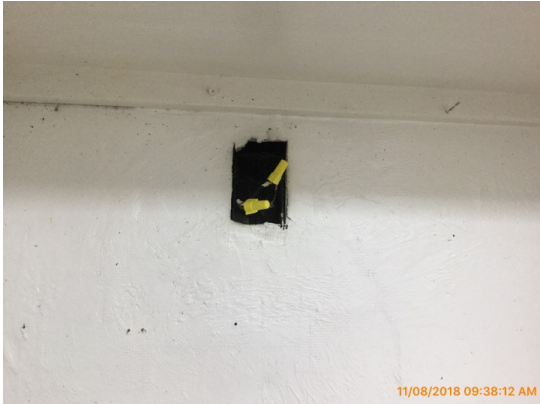
- south wall of the kitchen at the cavity for the refrigerator (See Photo 1)
- under the kitchen sink (See Photo 2)
- southwest kitchen cabinet (See Photo 3)
- upstairs north closet (See Photo 4)
- west upstairs landing (See Photo 5)

South wall kitchen at refrigerator cavity.

Correction to a professional standard is required for safety.

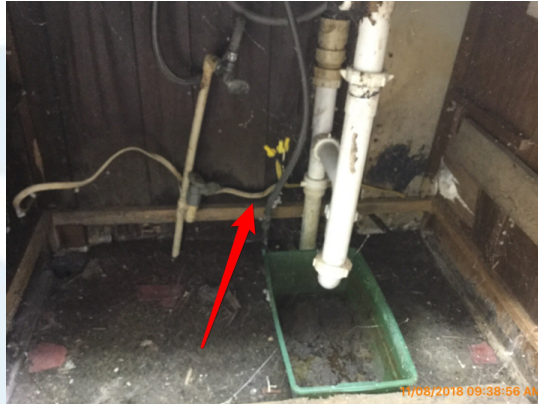
Exposed Romex under kitchen sink.

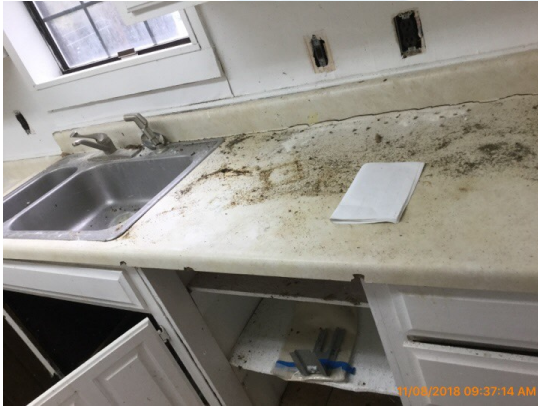
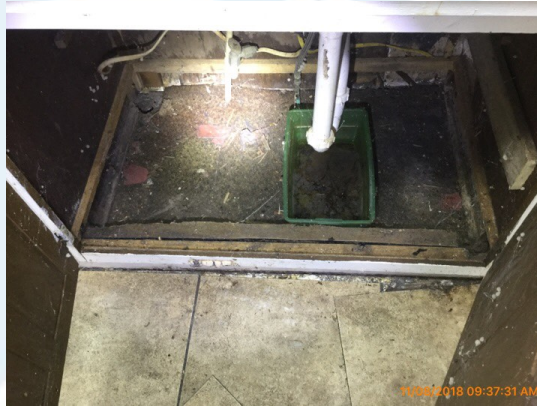
MAJR DFCT 98: - Kitchen cabinets have varying amounts of wear and tear/damage to the point that budgeting for repairs/replacment is advised and should be budgeted for.

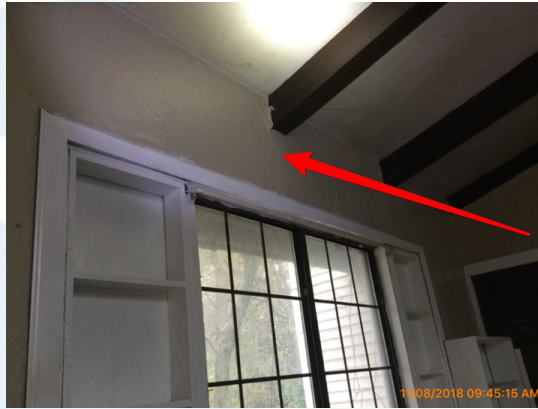
South living room above windows

- north dining room. (See Photo 1)
- south wall of living room above windows (See Photo 2)
- upstairs ceiling (See Photo 3)
- north upstairs balcony (See Photo 4)
- upstairs southwest bedroom (See Photo 5)

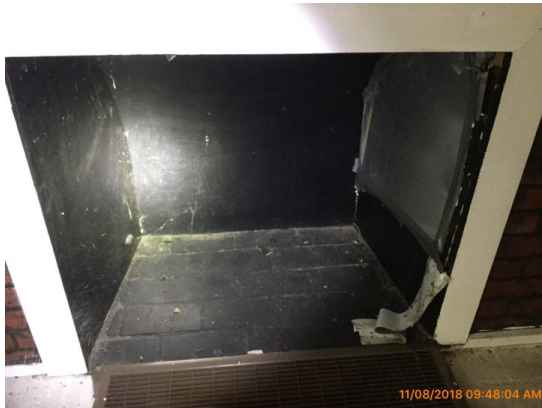
115: - Fireplace at living room is a faux fireplace and is not intended for use with combustible materials. Consider removal.

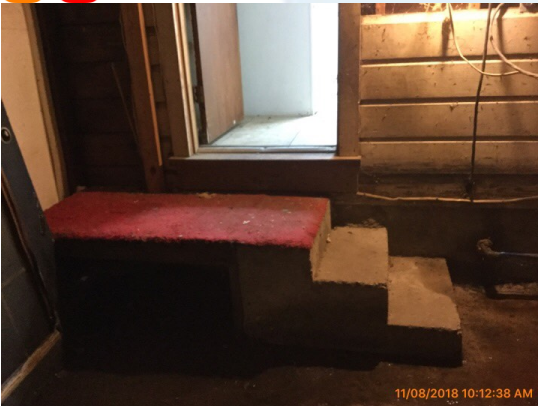
SFTY **DFCT** 122: - Installation of a handrail at the garage steps is advised for improved safety.

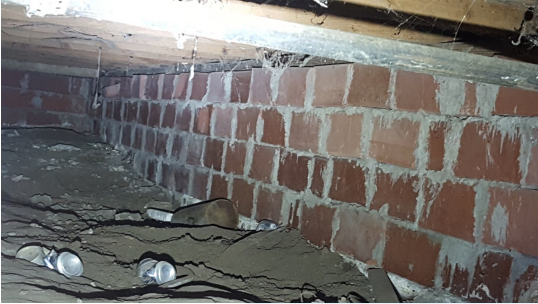
124: - Foundation: Crawl Space

125: - Foundation Wall: Clay Tile Masonry Unit and Concrete Masonry Unit

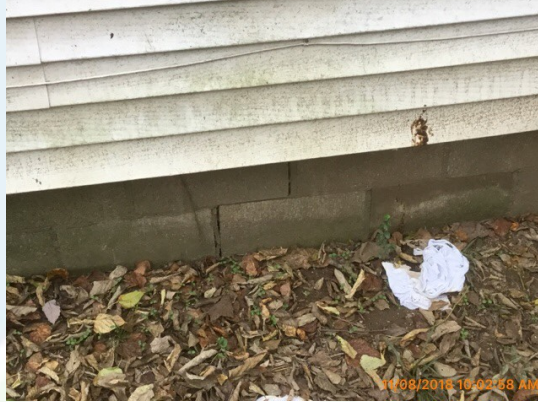
- The north facing wall of the garage just east of the overhead door is bowed inward indicative of likely impact. (See Photo 1)
- mortar step crack at the west facing southwest corner. (See Photo 2)

- hole in the foundation wall at the west/northwest. (See Photo 3)
- floor at the kitchen/living room common wall deflects significantly at the point of the contact of the common wall.

- residence appears to have been "added on to" by installation of an addition for the west garage and upstairs living space, as well as opening up of the living room area to a full two stories at the interior.

- reinforcement or additional support was likely not installed at the crawl space at the affected area of floor deflection.
- we recommend further evaluation by a qualified professional contractor and/or engineer to determine a course of action for correcting the deflection in the flooring prior to any intended upgrades to the interior.

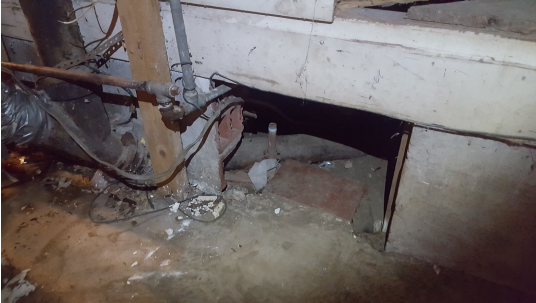
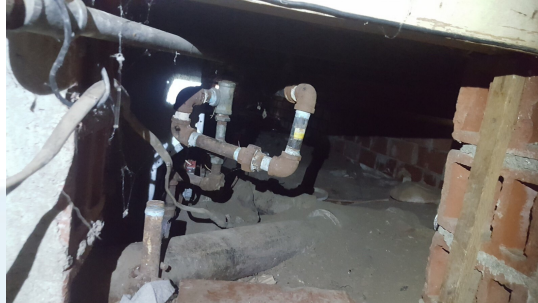
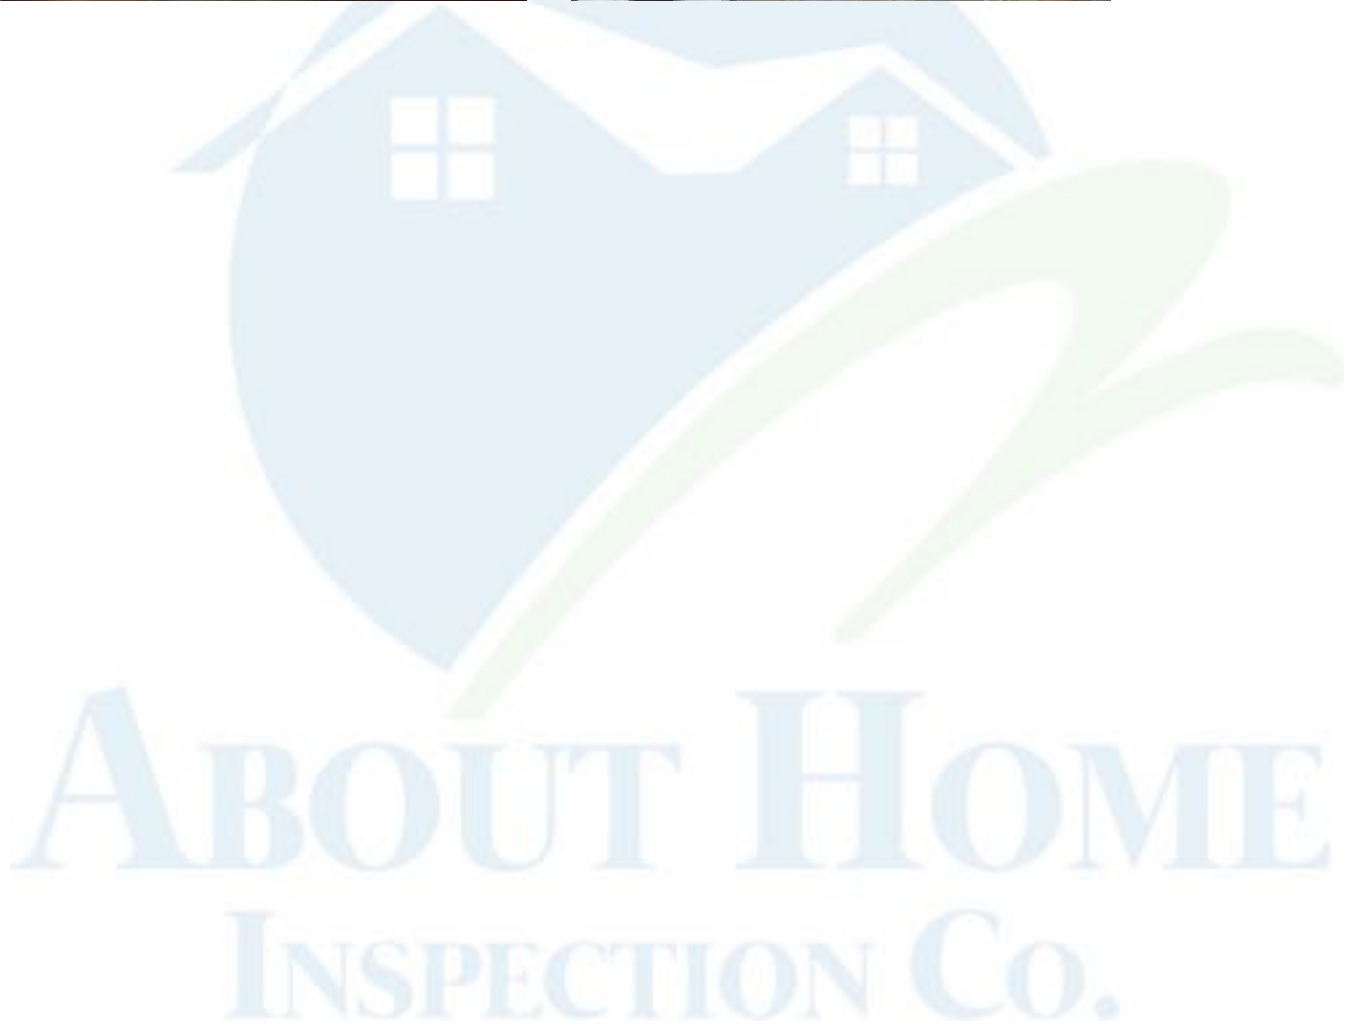
EVAL **DFCT** **127:** - Crawl space is inaccessible due to installation of a gas line at the entry blocking access. Opening is also not a minimum of 18x22. Inspection is limited to a "look-in" only from the access scuttle. Improvement of access for inspection is needed in order to complete this General Home Inspection.
